## A.L.R. MERRIFIELD DISCUSSES SOME ASPECTS OF WIND AND RAILWAY ENGINEERING

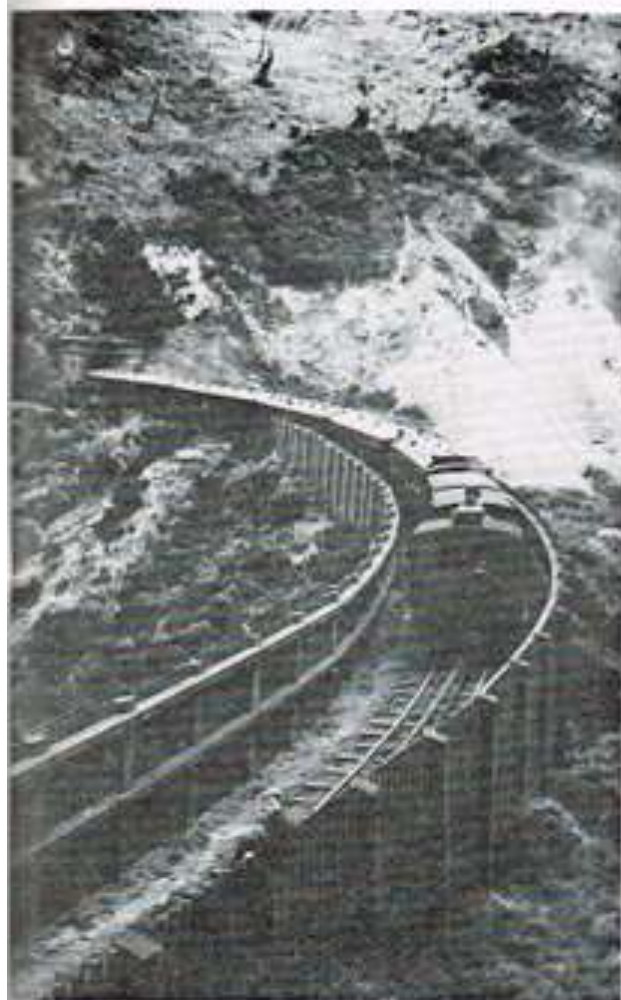
The "Weirarapa Mail" of bygone days descending the 1 in 15 Rimutaka Incline from Summit to Cross Creek. It is emerging from Siberia Tunnel and crossing the deep gully down which high winds are prone to sweep during north-westerly gales.

in the Rimutaka ranges suggests John Carruthers' estimate to be feasible. Additionally, Siberia gully is a natural wind-funnel. This analysis ignores his statement that the carriages did not just overturn, but were swept bodily off the rails.
